STEAM LINK®

ACTIVE INSTALLATION

Yesterday's steam distribution system, supporting today's process application.

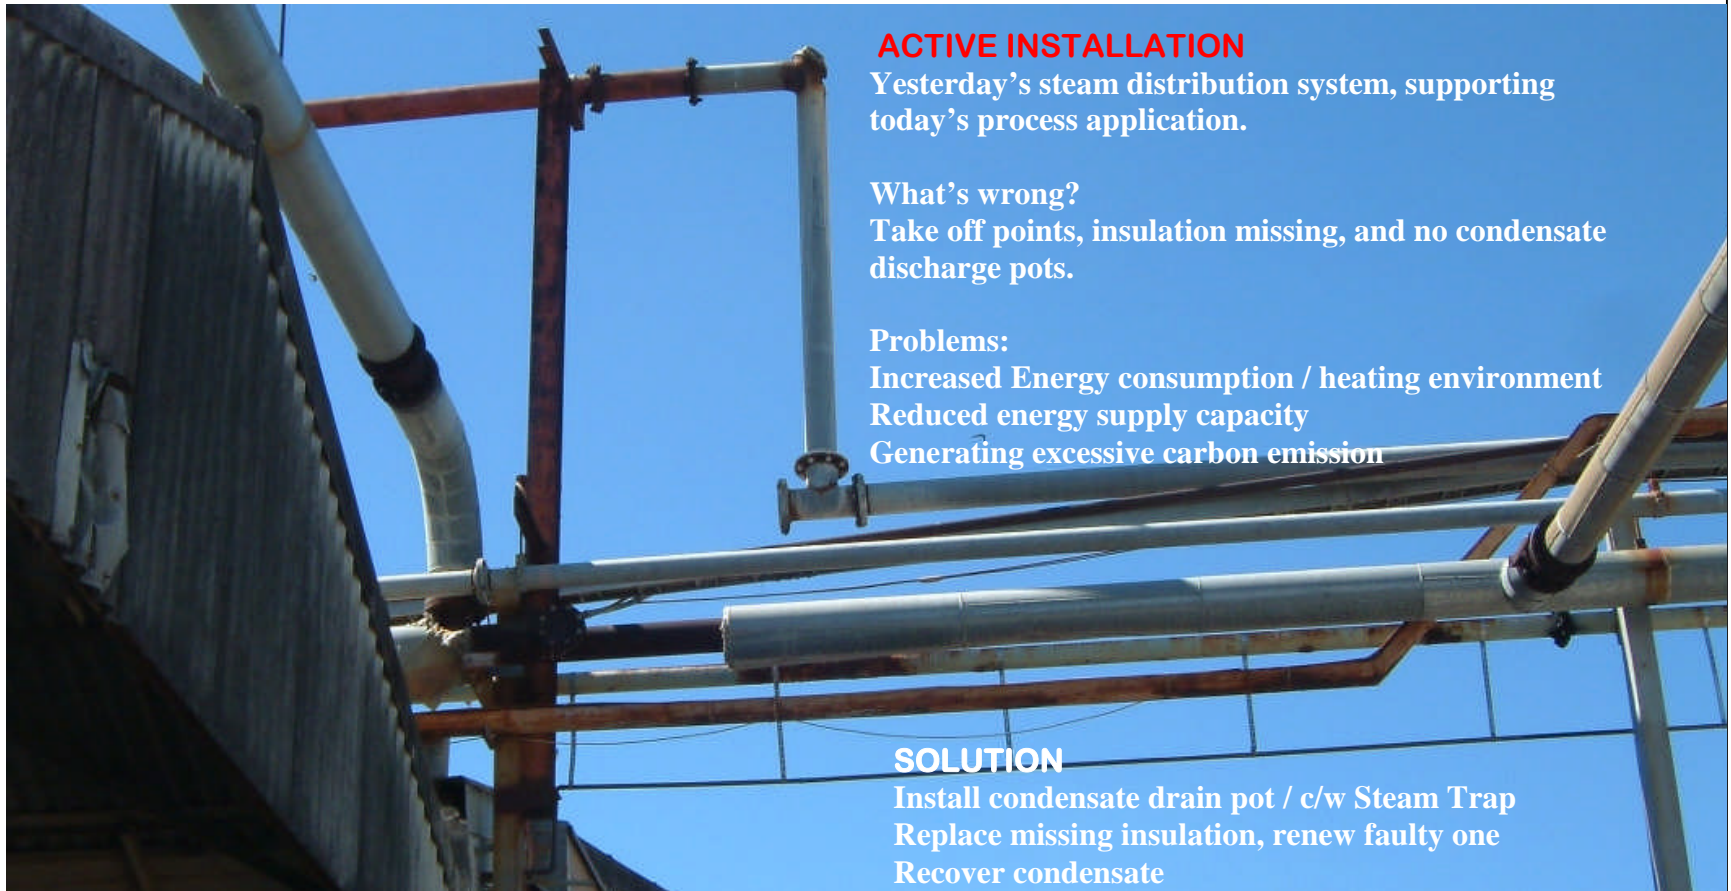
What's wrong?

Take off points, insulation missing, and no condensate discharge pots.

Problems:

Increased Energy consumption / heating environment
Reduced energy supply capacity
Generating excessive carbon emission

SOLUTION

Install condensate drain pot / c/w Steam Trap
Replace missing insulation, renew faulty one
Recover condensate
